# **Assessment of Hybrid Type Shore Erosion Control Projects in Maryland's Chesapeake Bay Phases I & II**

**David G. Burke**  
Burke Environmental Associates  
Annapolis, Maryland

**Evamaria W. Koch & J. Court Stevenson**  
Horn Point Environmental Laboratory  
University of Maryland Center for Environmental Science  
PO Box 775 Cambridge, Maryland 21613

**March, 2005**

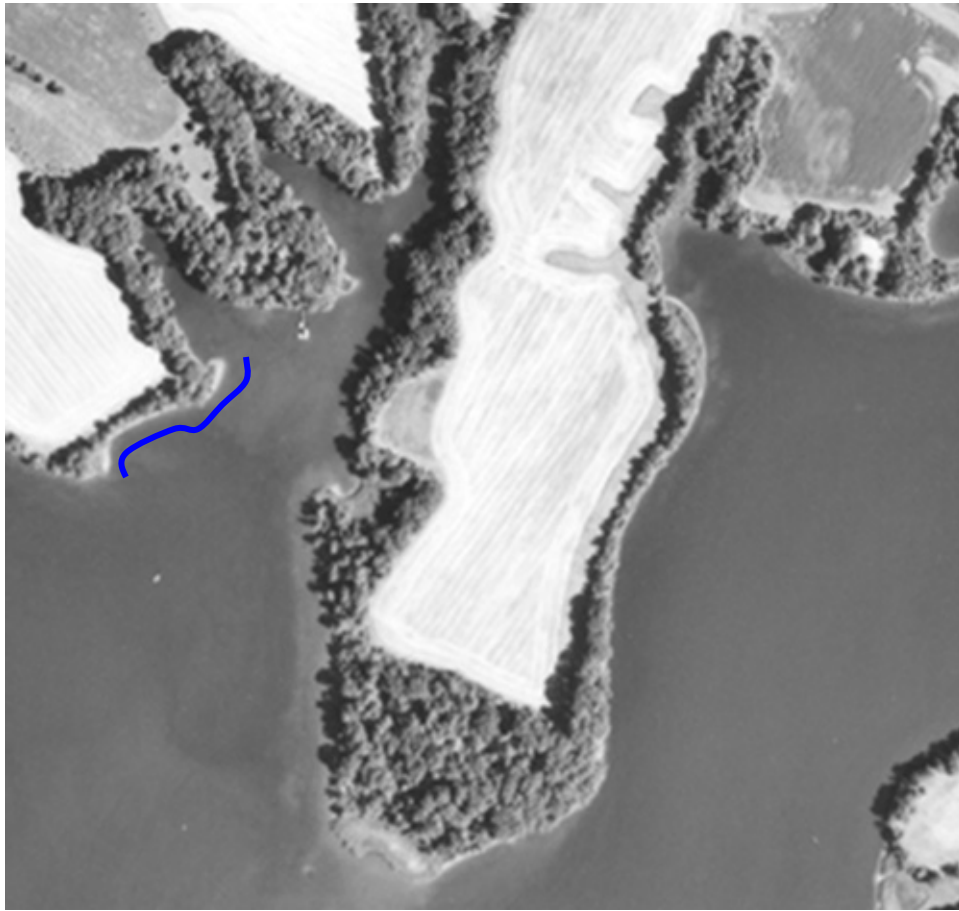
**Figure 5. Aerial View of Wye NRMA site.** The groins at Wye NRMA do not seem to extend far enough into the water to trap the sediment being transported by longshore currents. As a result, a sand spit is forming at the eastern end of the project (arrow). Perhaps only fetch and wave climate were considered when designing this structure but boat-generated waves appear to also be quite significant at this site.

In contrast, at Wye NRMA, sand seems to be transported by storm events or during high tides forming a sand spit at the northern end of the study site (Figure 5). This sand spit has been deposited in relatively deep waters forming a very steep shoreline (Figure 4 Wye NRMA 39+70). It appears that if the groins had extended farther offshore they

could have trapped more of these sediments minimizing the formation of this sand spit. Other areas adjacent to the study site are less steep and extensive shallows can extend quite far offshore (Figure 4 Wye NRMA 32+20). Such shallows attenuate waves as they propagate onshore thereby protecting the shoreline even in the absence of breakwaters or groins.

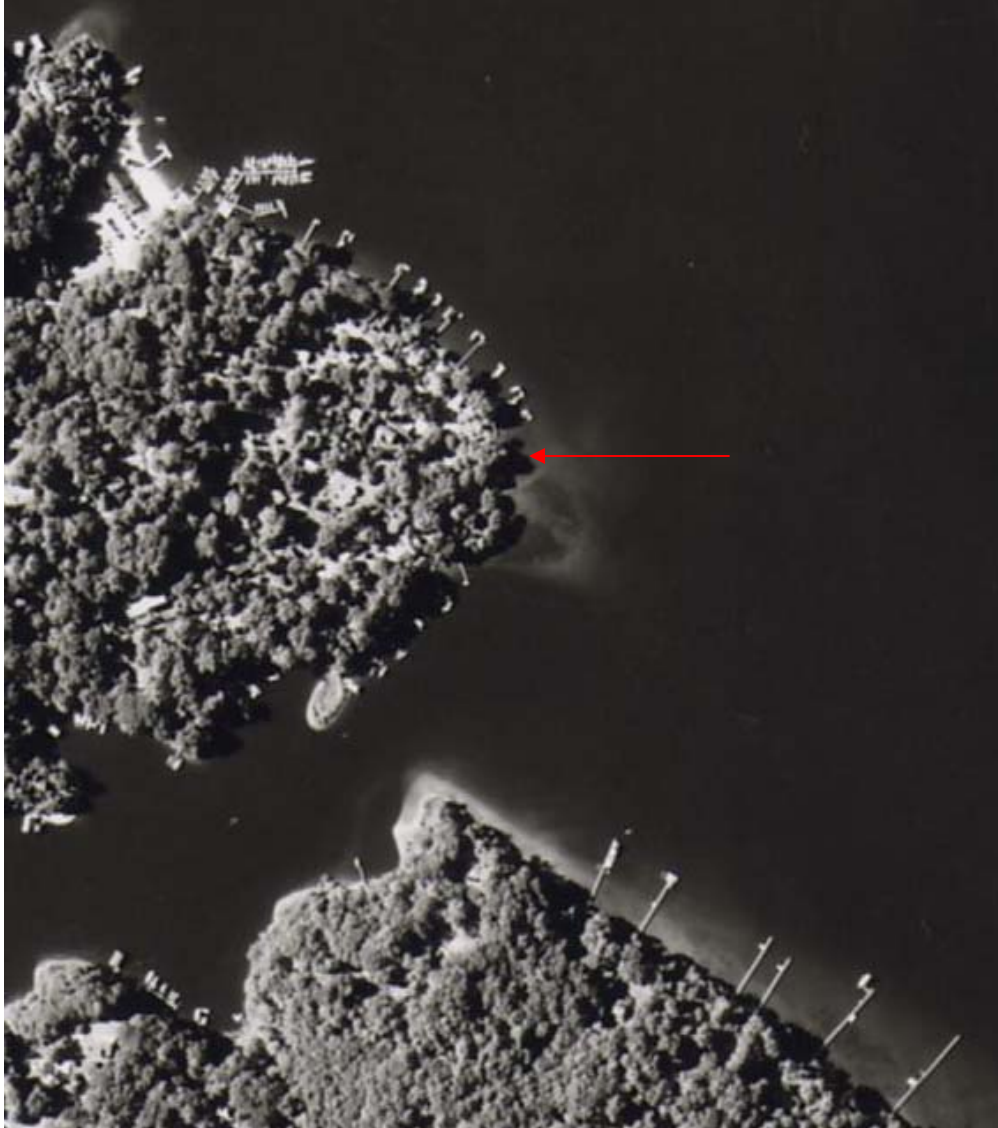
**Figure 8. Aerial view of the Epping Forest Site.** Note the sediment fan just south of the vegetated breakwater (red arrow).

The vegetated sill at Epping Forest is located adjacent to the mouth of a creek that deposits sediments in the form of a fan in the offshore area (Figure 8). As a result, the slope of the shoreline is gentle (Figure 7) and supports some submersed aquatic vegetation (SAV); *Ruppia maritima* and *Potamogeton perfoliatus*. The source of the sediment is not only the creek but also adjacent embankments that are/were eroding. The adjacent areas appear quite sediment-starved (lack of sedimentary features).

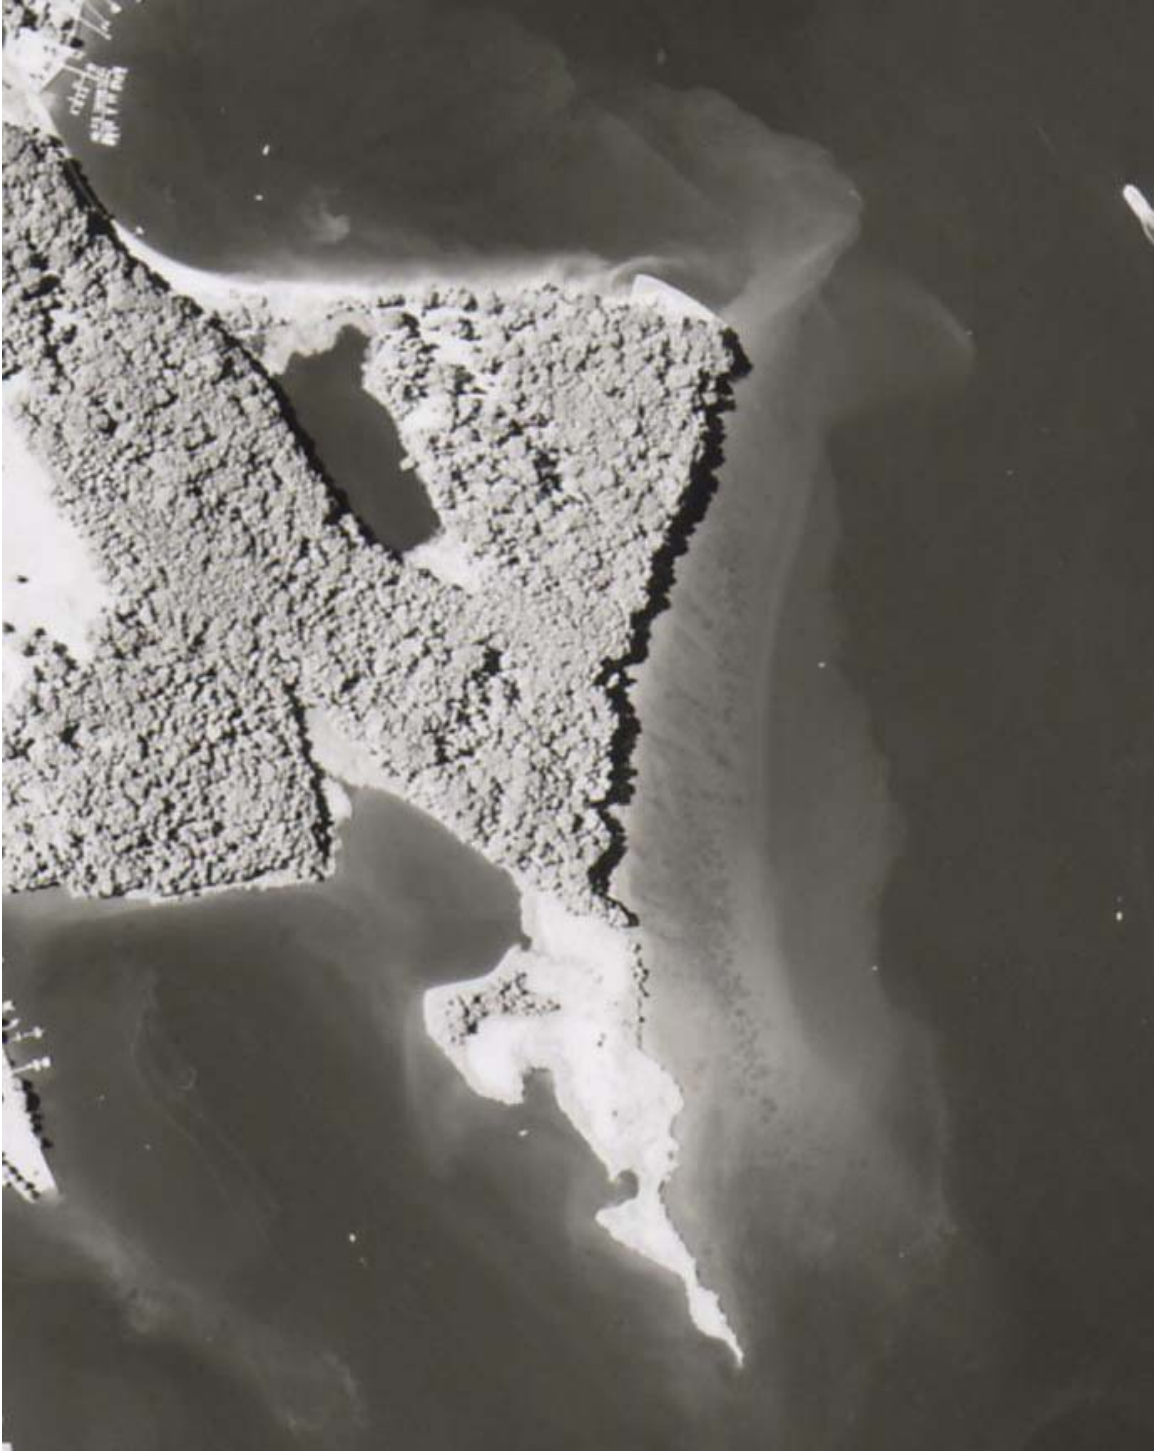
**Figure 11. Aerial view of the South River Farm Park Site.** The structure at this site is obscured by the shadow of the trees. Note the broad shoal adjacent to the shore and the patches of submersed aquatic vegetation.

The area adjacent to the South River Farm Park site is characterized by a broad sand shoal (Figure 11) with a gentle slope (Figure 7) which is colonized by *Ruppia maritima*. This SAV bed, although sparse, was quite extensive and flowering at the time of sampling. The source of sediment that formed this shoal may be the eroding bank at the study site and/or the beaches south and northwest of there. Independent of the source, sediment dynamics in this area is extensive as can be seen by the patterns in Figure 7.

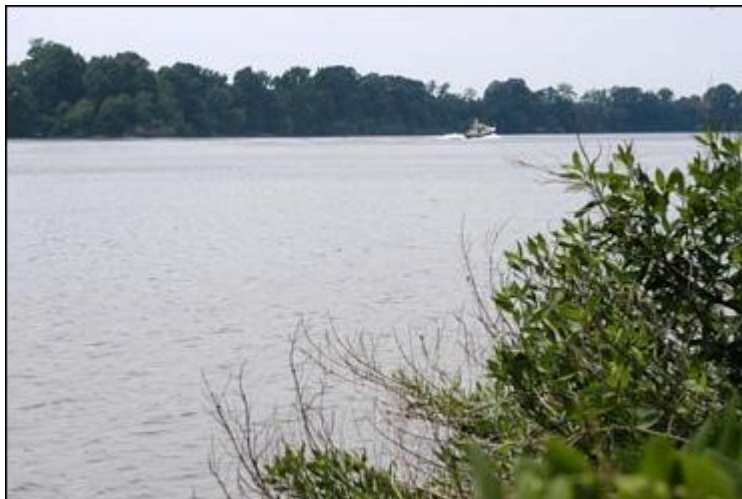
**Figure 13. Boat navigating the Wye River near the shoreline project**

There was one clump of marsh plants which was eroded into the sub-tidal area. A sill might be a better option at this location to help protect the marsh from wave action which appeared to be exacerbated by boat traffic in traveling in the channel of the Wye River (Figure 13).

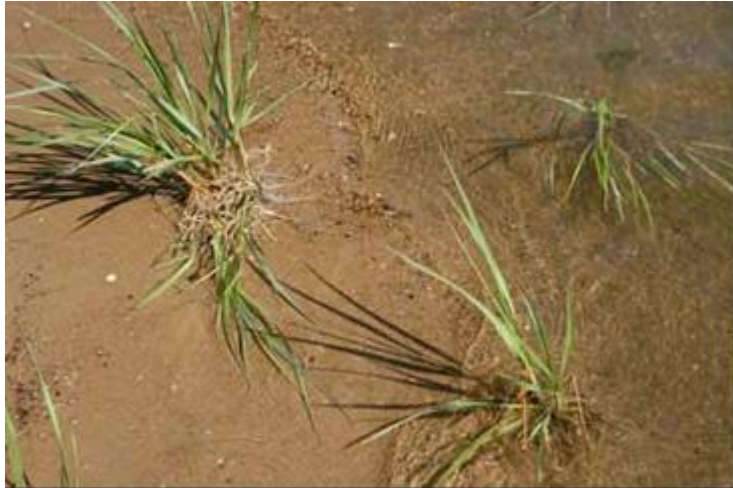
**Figure 18. Eroded substrate of *Spartina* at Epping Forest.**

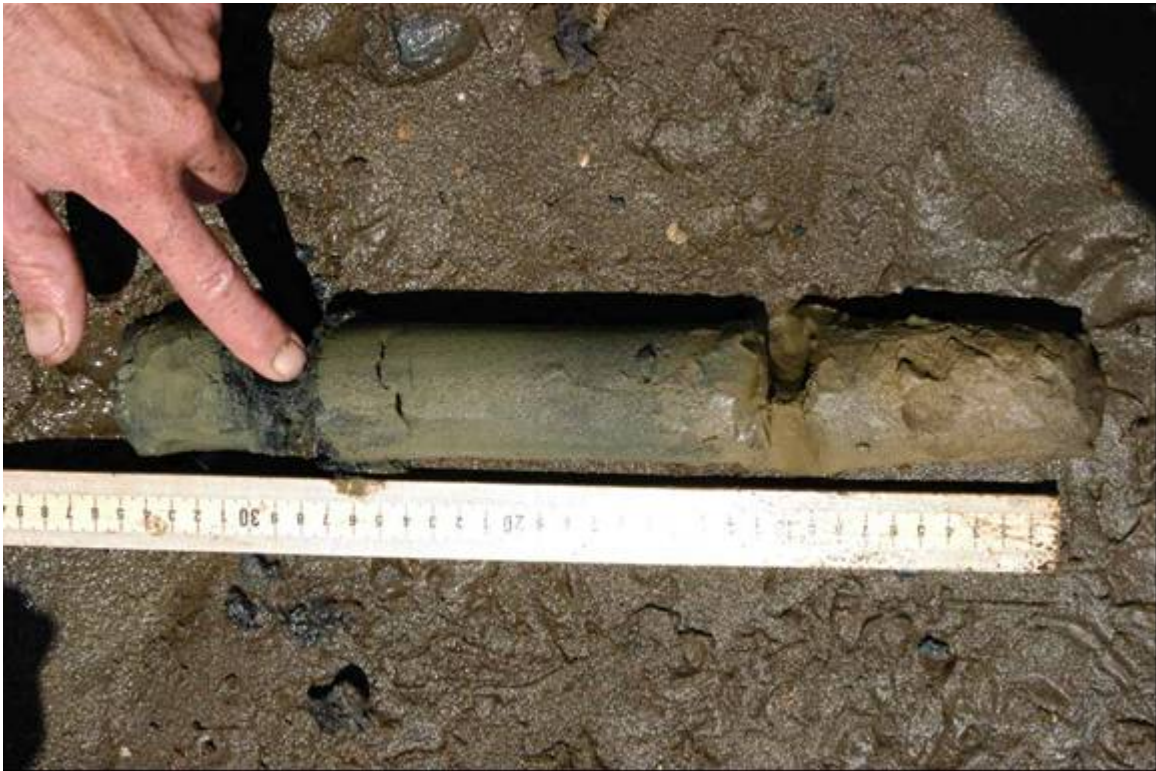
**Figure20. Sediment core at South R. Farm Park, June 2004 showing 5-6 cm over the old black organic marsh layer.**
