# LIVING SHORELINES:

## Guidance for Sarasota Bay Watershed

Prepared for  
Sarasota Bay Estuary Program

June 2018

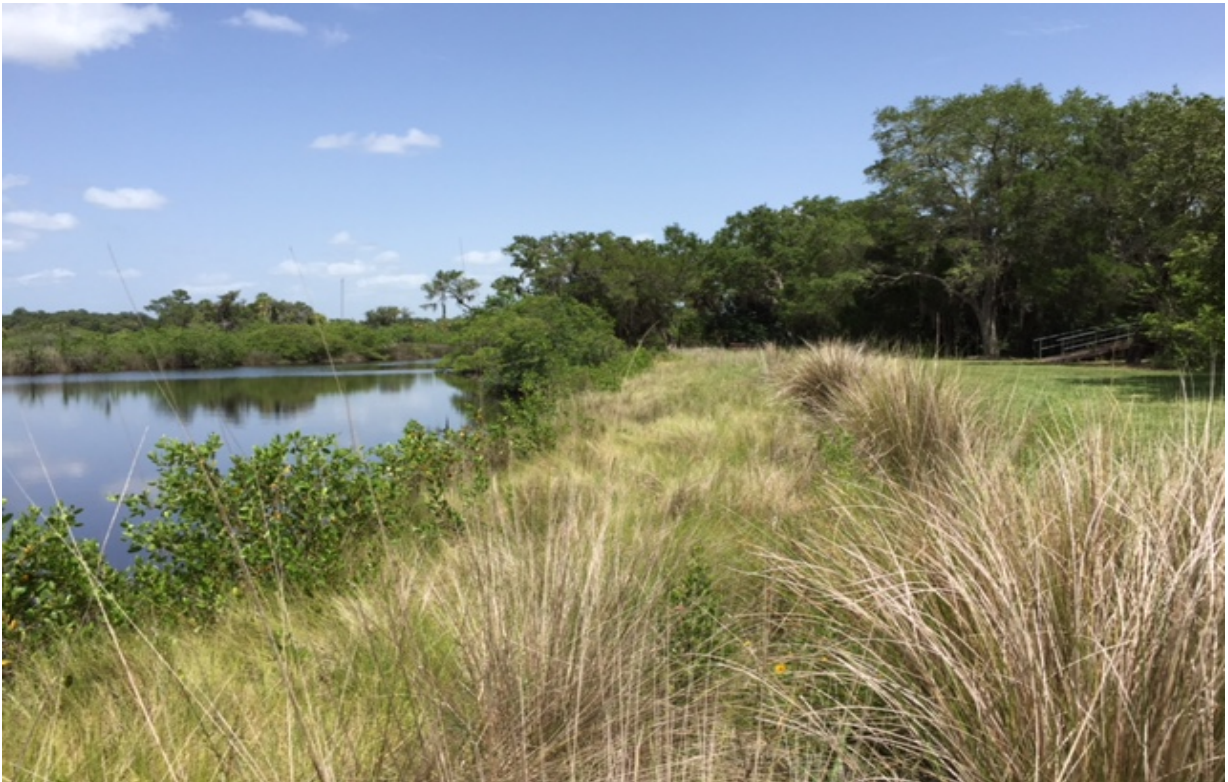
**Living Shoreline Solution after Removal of a Seawall at the Honi Hanta Girl Scout Camp in Bradenton, Florida**
